Manhole Inspection Summary

Manhole # S3100_008MH

Insp Date: **4/25/07 11:07 AM**

Location Address: **330 SISSON ST**

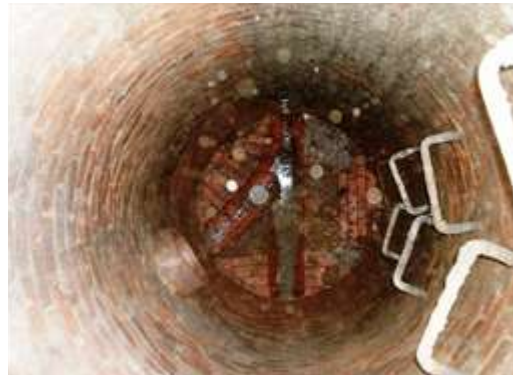
Top View

Corroded steps. Bench and Channel debris.

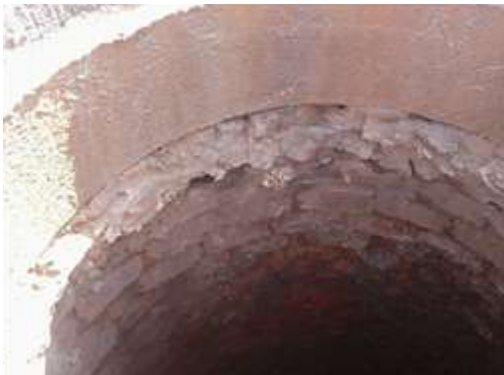
Defect

Frame leaks. Adjustment deterioration and infiltration. Corbel infiltration.

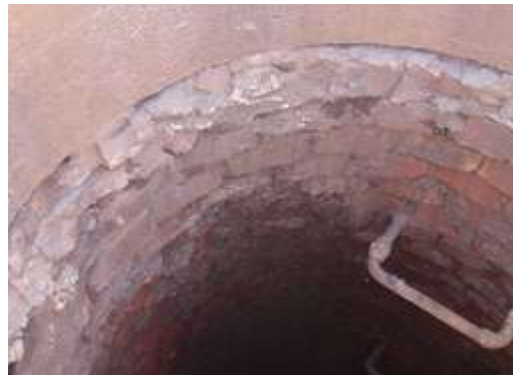
Defect

Frame leaks. Adjustment deterioration and infiltration. Corbel infiltration - other side.

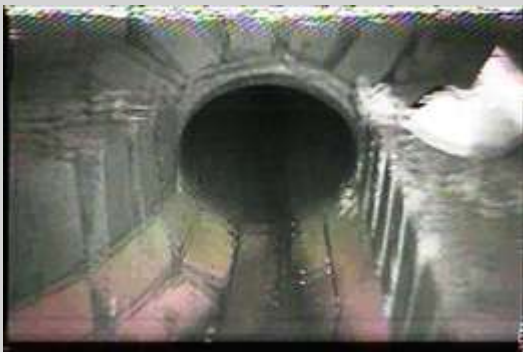
8 in. Circular Gravity Sewer Pipe Out @ 12 O'Clock

Infiltration: **None** Pipe Seal Cond: **Broken**

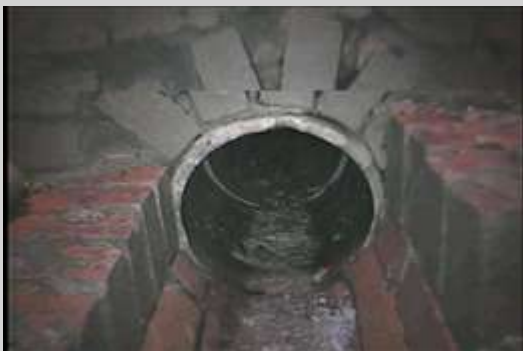
8 in. Circular Gravity Sewer Pipe In @ 6 O'Clock

Deposits: ☐ None ☐ Mud ☐ Sludge ☐ Debris ☒ Grease

Silt Depth: **0** (in.) Deposits Extent: **Light**

Infiltration: **Evidence** Pipe Seal Cond: **Unknown**

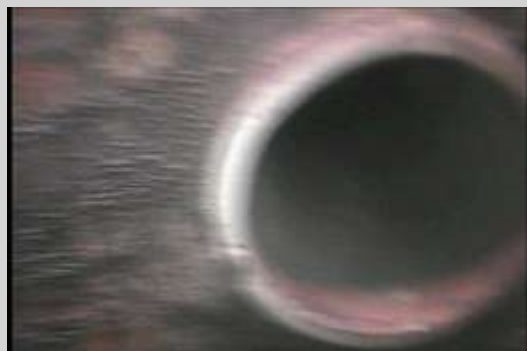
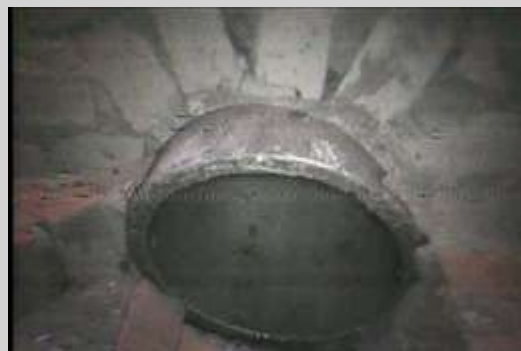
Pipe In @ 8 O'Clock

Infiltration: **Evidence**

Drop: **Outside** Rod and Bar
